Manhole Inspection Summary

Manhole # S47S1_001MH

Insp Date: **6/5/08 3:05 PM**

Location Address: **3100 Childs St.**

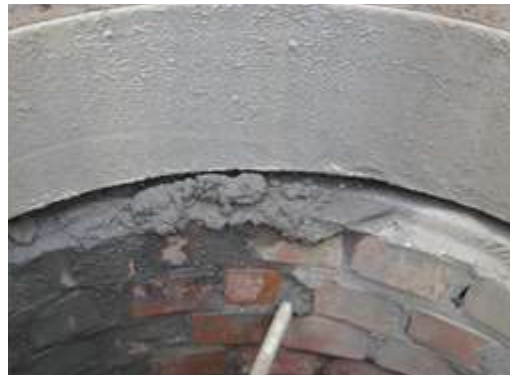
Defect 2

Condition: ☐ Sound ☒ **Cracked** ☐ Root Intrusion ☐ Loose Brick ☐ Deteriorated

Infiltration: ☐ None ☒ **Joint** ☐ Cracks ☐ Mortar ☐ Roots ☐ Wall

Frame-Chimney Joint

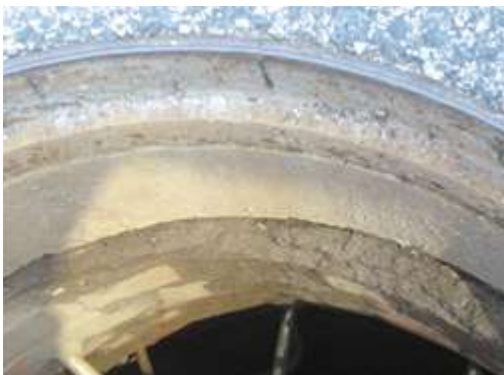
Defect 1

Offset: **1** (in.)

Condition: ☐ Sound ☒ **Cracked** ☐ Leaks

Frame offset

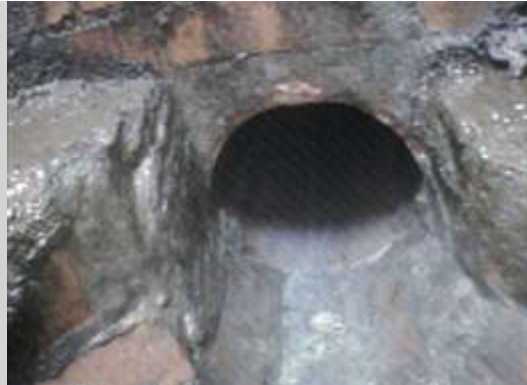
12 O'Clock Outflow

8 in. Circular Gravity Sewer
Pipe Out @ 12 O'Clock

Pipe Height: **7.2** (in.) Rod and Bar (Angled)
Pipe Material: **Clay** ☐ Pipe Lined
Invert Depth: **7.90** (ft.) Flow Characteristics: **Fast**
Deposits: ☒ None ☐ Mud ☐ Sludge ☐ Debris ☐ Grease
Silt Depth: (in.) Deposits Extent:
Infiltration: **None** Pipe Seal Cond: **Sound**

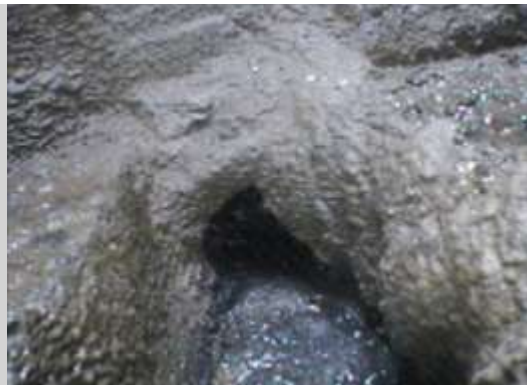
3 O'Clock Inflow

Comments **Unable to accurately measure influent pipe @ 3 O'Clock due to blockage.**

6 in. Circular Service Sewer
Pipe In @ 3 O'Clock

Pipe Height: **3.6** (in.) Rod and Bar (Angled)
Pipe Material: **Clay** ☐ Pipe Lined
Invert Depth: **1.00** (ft.) Flow Characteristics: **Slow**
Deposits: ☐ None ☐ Mud ☒ **Sludge** ☐ Debris ☐ Grease
Silt Depth: **1** (in.) Deposits Extent: **Light**
Infiltration: **None** Pipe Seal Cond: **Unknown**

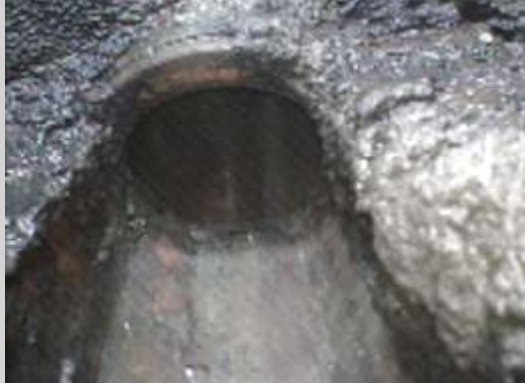
6 O'Clock Inflow

6 in. Circular Gravity Sewer

Pipe In @ 6 O'Clock

Invert Depth: **7.20** (ft.) Flow Characteristics: **Fast**

Connects To: **Dead End**

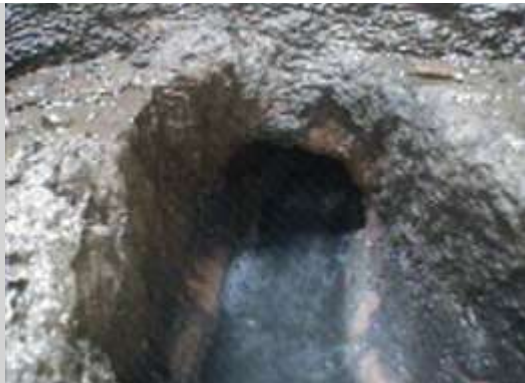
9 O'Clock Inflow

6 in. Circular Gravity Sewer

Pipe In @ 9 O'Clock

Invert Depth: **7.70** (ft.) Flow Characteristics: **Fast**

Infiltration: **None** Pipe Seal Cond: **Sound**
